Some Observations on the Architecture of the Roman Theatre of Iznik (Nicaea)

Aygün Ekin Meriç* - Ali Kazım Öz**

Abstract

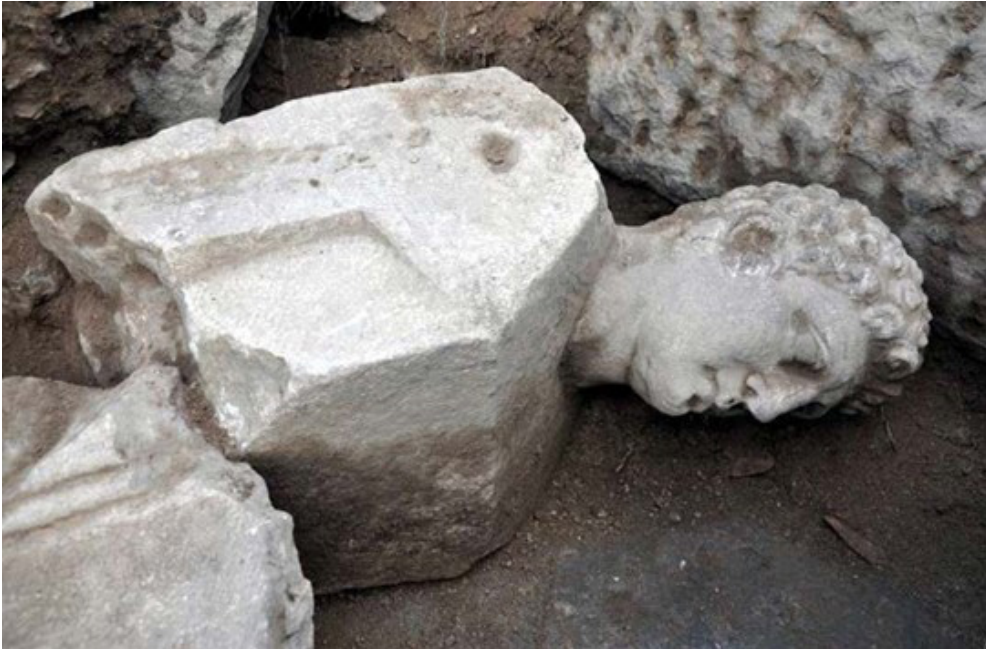
Fig. 16. Hermae in east portico (courtesy of the Roman Theatre Excavation at Nicaea 2017)
